Manhole Inspection Summary

Manhole # S37AA_002MH

Insp Date: **1/9/08 11:19 AM**

Location Address: **521 forrest st**

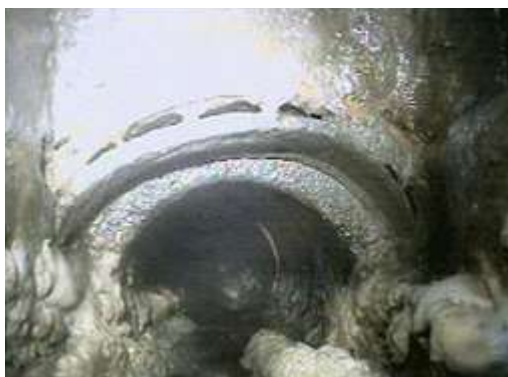
Defect 1

Infiltration: ☐ None ☐ Joint ☐ Cracks ☐ Mortar ☐ Roots ☒ **Wall**

Condition: ☐ Sound ☐ Cracked ☐ Root Intrusion ☒ **Deteriorated** ☐ Leaks ☐ Debris

Barrel Infiltration, Deteriorating Channel

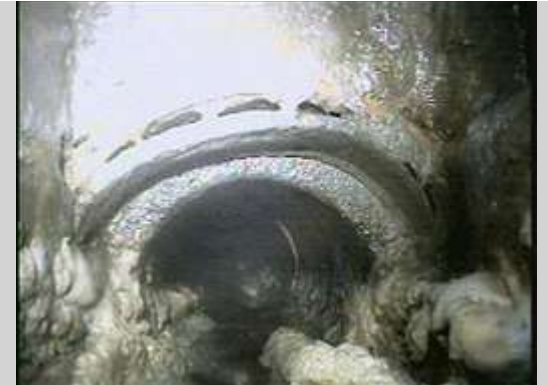
12 O'Clock Outflow

8 in. Circular Gravity Sewer
Pipe Out @ 12 O'Clock

Deposits: ☐ None ☐ Mud ☐ Sludge ☒ **Debris** ☐ Grease

Silt Depth: **2** (in.) Deposits Extent: **Light**

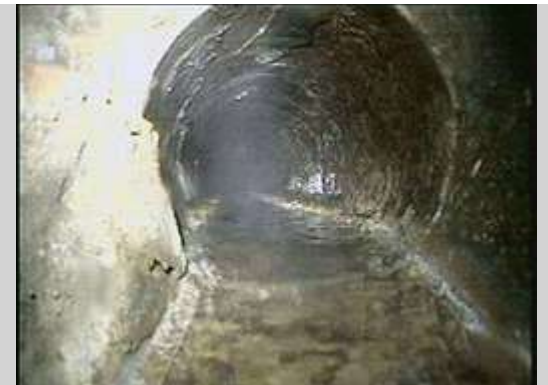
4 O'Clock Inflow

8 in. Circular Gravity Sewer
Pipe In @ 4 O'Clock

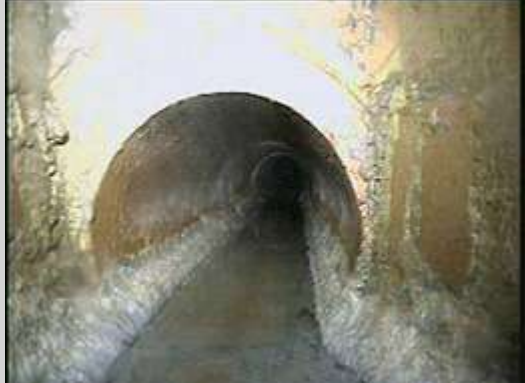
7 O'Clock Inflow

Pipe In @ 7 O'Clock
